Walkability Assessment of Differently-abled People within a Public Transport District: A Case Study of Colombo Pettah, Sri Lanka

Shameen Dharmasena*, M.K. Sanduni Saubhagya, Sandumini Nimashi, Janaka Dharmasena¹

Department of Architecture, University of Moratuwa, Sri Lanka

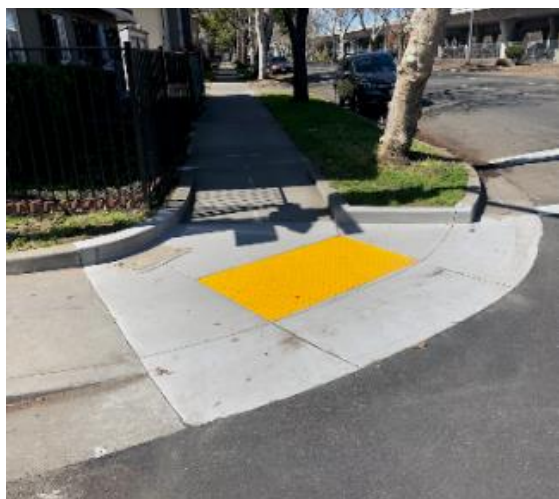
Figure 3. Pedestrian Ramp for Disabled,
Source: Google Images

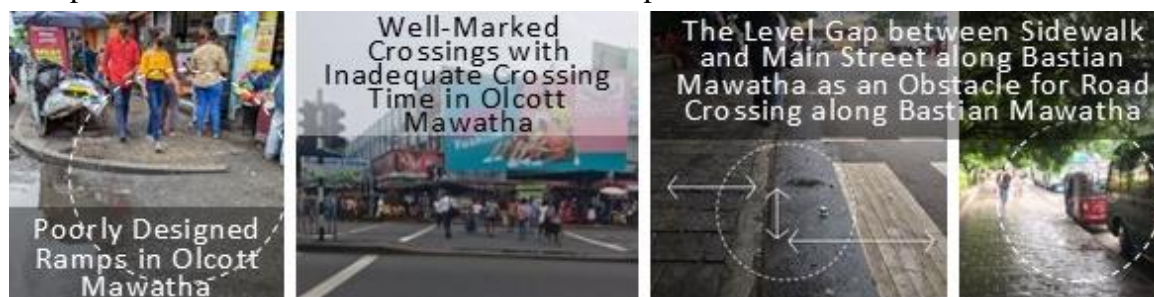
Figure 7. Walkability Score for Olcott Mawatha and W.E. Bastian Mawatha

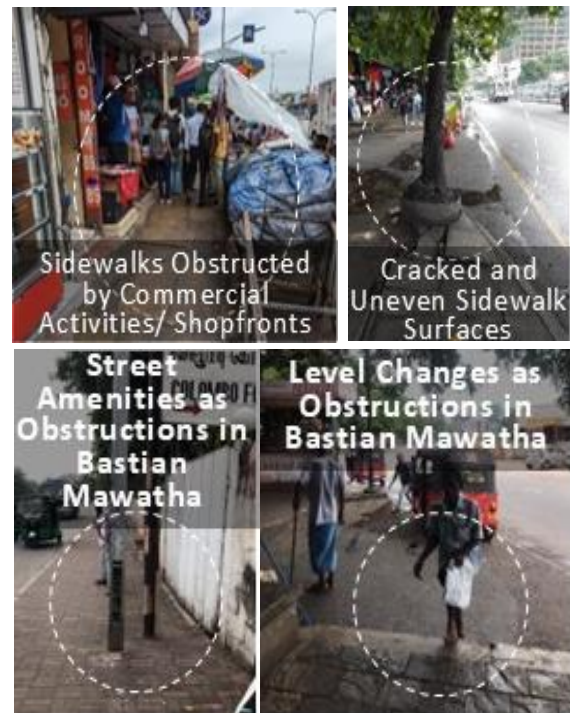
Conversely, the sidewalks and pathways along Bastian Mawatha generally displayed commendable maintenance, earning a score of 32%. Nevertheless, certain sections experienced obstructions, such as rough paving patterns and sudden level changes, proving inconvenient for those with mobility and vision impairments. Despite having adequate width, the sidewalks posed challenges for wheelchair users due to activities causing significant hindrances. Additionally, street amenities like streetlights without tactile signs, garbage, and adjacent shopfronts further posed barriers to walkability. Particularly around the Railway Station, pedestrians encountered challenges due to the absence of designated walking spaces. The presence of shopfronts that opened directly onto the sidewalks created obstacles and inconveniences for those on foot. However, the presence of curb ramps at intersections represented a notable improvement in accessibility.(Figure 9)

Figure 9. Observed Obstructions Along the Street Sidewalks in Olcott Mawatha
Source: Compiled by the Author

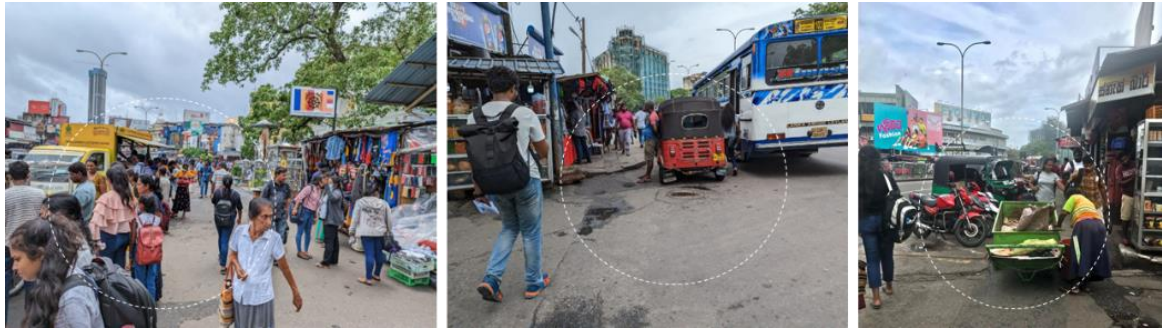
In the assessment of pedestrian safety along Olcott Mawatha, a score of 36% was assigned, reflecting a mixed picture of safety measures along the thoroughfare. Notably, certain sections of Olcott Mawatha demonstrated commendable efforts in ensuring pedestrian safety, particularly in proximity to the railway station and transit hubs. These areas boasted well-designed pedestrian infrastructure, including separated walkways from vehicular traffic and accessible facilities such as ramps, enhancing overall safety for pedestrians. However, despite these positive aspects, significant deficiencies in pedestrian safety persisted along Olcott Mawatha, primarily attributed to the challenges posed by heavy traffic flow and inadequate infrastructure management. Observations uncovered significant gaps, notably in sections where pedestrian zones lacked clear demarcation. This absence of distinct boundaries raised safety concerns, especially as pedestrians navigated areas intermingled with commercial activities and vending carts. Furthermore, issues concerning the visibility of pedestrian crossings emerged as a key safety concern. In certain instances, both drivers and pedestrians faced challenges due to insufficient visibility of designated crossing points, potentially jeopardizing safety for all road users.(Figure 10)

Figure 10. Observed Shortcomings in terms of Safety along Olcott Mawatha
Source: Compiled by the Author

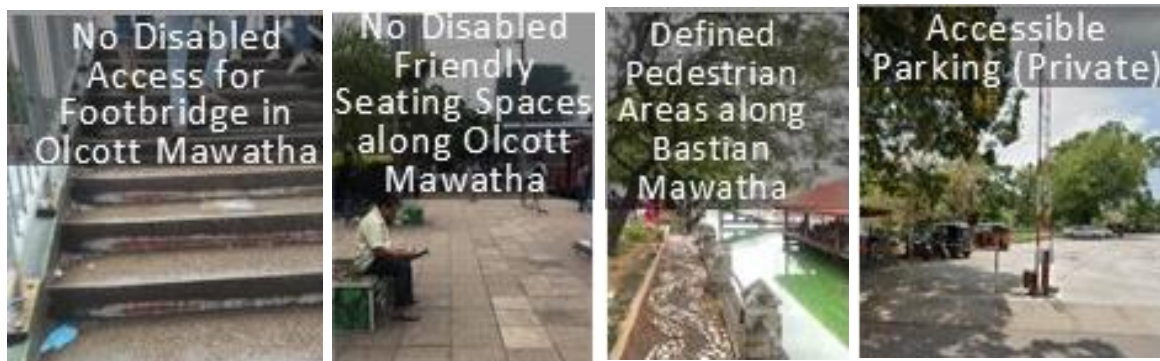
In contrast, Bastian Mawatha received a score of 60%. This thoroughfare demonstrated more comprehensive accessibility provisions, encompassing both private and publicly accessible parking spaces conveniently positioned near entrances, coupled with ramps for easy access. Notably, designed seating and

Figure 11. Accessibility Conditions along Streets
Source: Compiled by the Author

cater to differently abled individuals. (Figure 11)

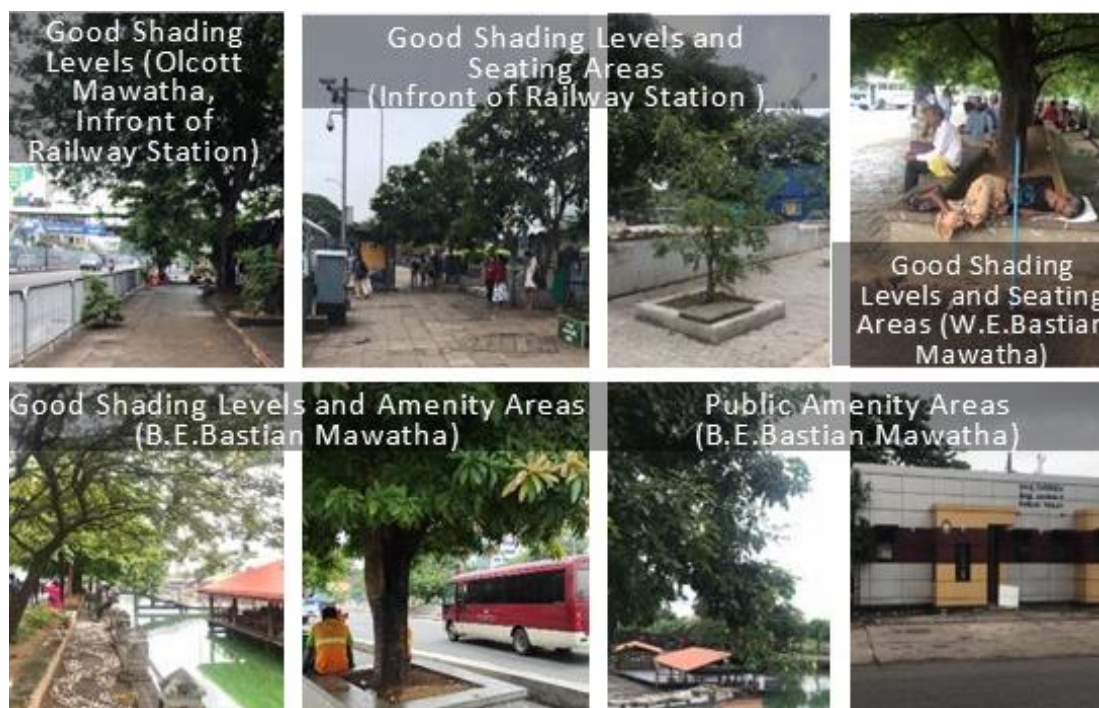
Based on the observations, Olcott Mawatha received a score of 52% for its amenities and comfort. It was noted that the thoroughfare provided accessible public transportation stops and stations in proximity, offering convenient access for pedestrians. Additionally, there were adequate shade and sheltered areas along pedestrian routes, particularly near the railway station and private bus stands. However, the availability of resting areas with suitable seating was limited, which could have been beneficial for individuals with disabilities. Furthermore, there was a noticeable absence of accessible drinking

In contrast, Bastian Mawatha received a significantly higher score of 80% for its amenities and comfort. Observations highlighted the presence of accessible public transportation stops conveniently situated along the thoroughfare, facilitating easy access for pedestrians. Particularly noteworthy were the well-appointed shade and sheltered areas along pedestrian routes, especially in front of the Floating Market, which featured ample resting spaces and appropriate seating. These amenities were particularly advantageous for individuals with disabilities seeking a rest stop. However, to further enhance comfort and

Figure 12. Existing Amenities and Comfortability Levels
Source: Compiled by the Author
